# Service Intervention Report

Purpose of the visit: entretien annuel chaudière gaz et défaut de pression circuit primaire · S003 · note-technicien.txt

Site: Résidence Les Tilleuls, bâtiment B, 12 rue des Tilleuls, 69003 Lyon · S003 · note-technicien.txt

Date: 31/07/2026 · S003 · note-technicien.txt

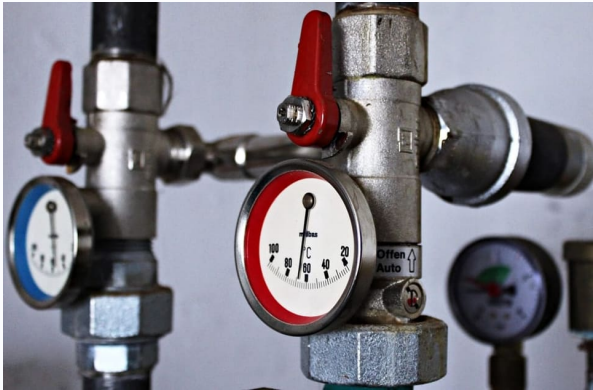
The photograph shows pipework with shut-off ball valves with red handles, a blue-rimmed dial indicator on the left, a central red-rimmed dial thermometer reading approximately 60 °C with printed markings "°C" and "Offen Auto", and another pressure gauge visible in the background. · from a photograph · S001 · 04-manometre-circuit.jpg
