# Site Documentation

Prepared 5 Sept 2026 · 4/5 sources included

### **1. S004 · arbeitsauftrag-aa-2026-0417.pdf · Work phase: Bauabschnitt 2, Nordfassade und Erdgeschoss**

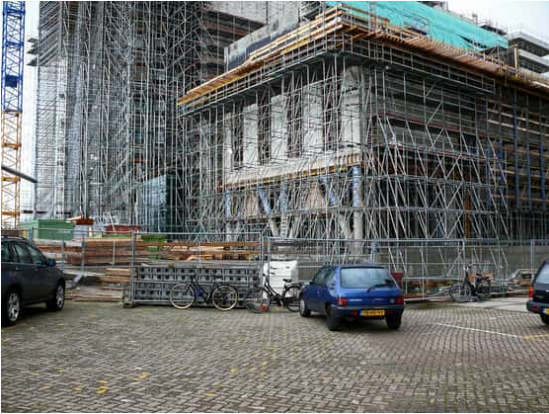
S001 · 01-geruest-nordfassade.jpg

Extensive multi-tier modular scaffolding covers the building facade, with timber shuttering/formwork visible at the upper levels and protective sheeting applied at the roof edge. A security mesh perimeter fence encloses the construction base, fronted by a paved parking area containing parked cars and secured bicycles.

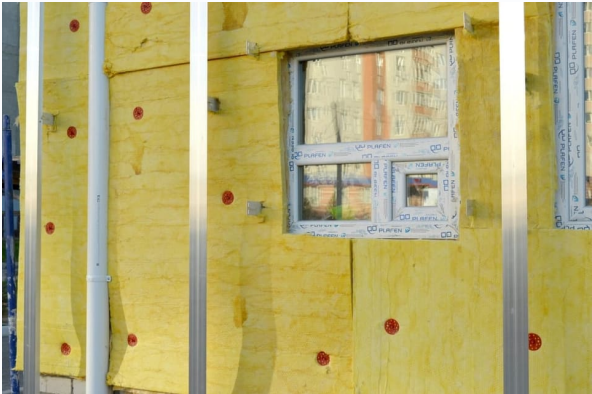
S003 · 06-daemmung-fassade.jpg

Yellow mineral wool insulation panels are affixed to the facade with red disc insulation anchors. Metal brackets and vertical subframe profiles are installed across the elevation. Double-glazed window units branded 'PLAFEN' are set in place, retaining protective tape along the PVC frames. A vertical white pipe is mounted down the left section of the wall.

WDVS-Restflaeche ab Achse C, ca. 100 m2 · S005 · bautagebuch-kw34.txt
